Fatalgrams and Fatal Reports

Fatality #14 - July 3, 2013 (Determined to be Chargeable September 4, 2013) Other (Drowning) - Facility - Pennsylvania Maple Creek Mining Incorporated - Maple Creek Preparation Plant

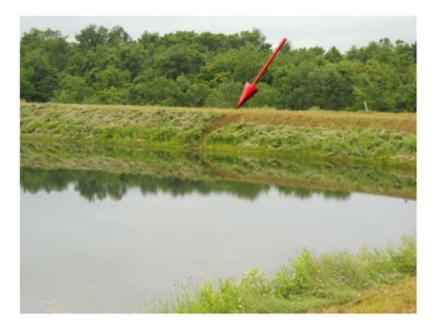
COAL MINE FATALITY - On July 3, 2013, an 87-year-old contract employee was mowing an impoundment embankment with a skid steer machine equipped with a front-mounted brush mower. The victim was mowing the 40 degree embankment in a vertical direction when the machine traveled into the impounded water, submerging the machine, and drowning the operator.

- Conduct a risk assessment prior to performing work and ensure that miners use proper equipment, tools, and procedures to eliminate hazards.
- Provide hazard training to all personnel working on or near an impoundment for recognition of hazards associated with the impoundment.
- Set up a communications protocol when persons are working alone.
- Wear properly fitted personal floatation devices (PFD) when working around bodies of water.
- Never assume an employee is knowledgeable in the task they are being assigned.
